ANNUAL REPORT FOR 2015

UT to Middle Fork Creek Site C Mitigation Site
Madison County
TIP No. R-2518A
COE Action ID: SAW-2007-2197-357/300
DWR #: 20071134

Prepared By:
Natural Environment Section & Roadside Environmental Unit
North Carolina Department of Transportation
November 2015

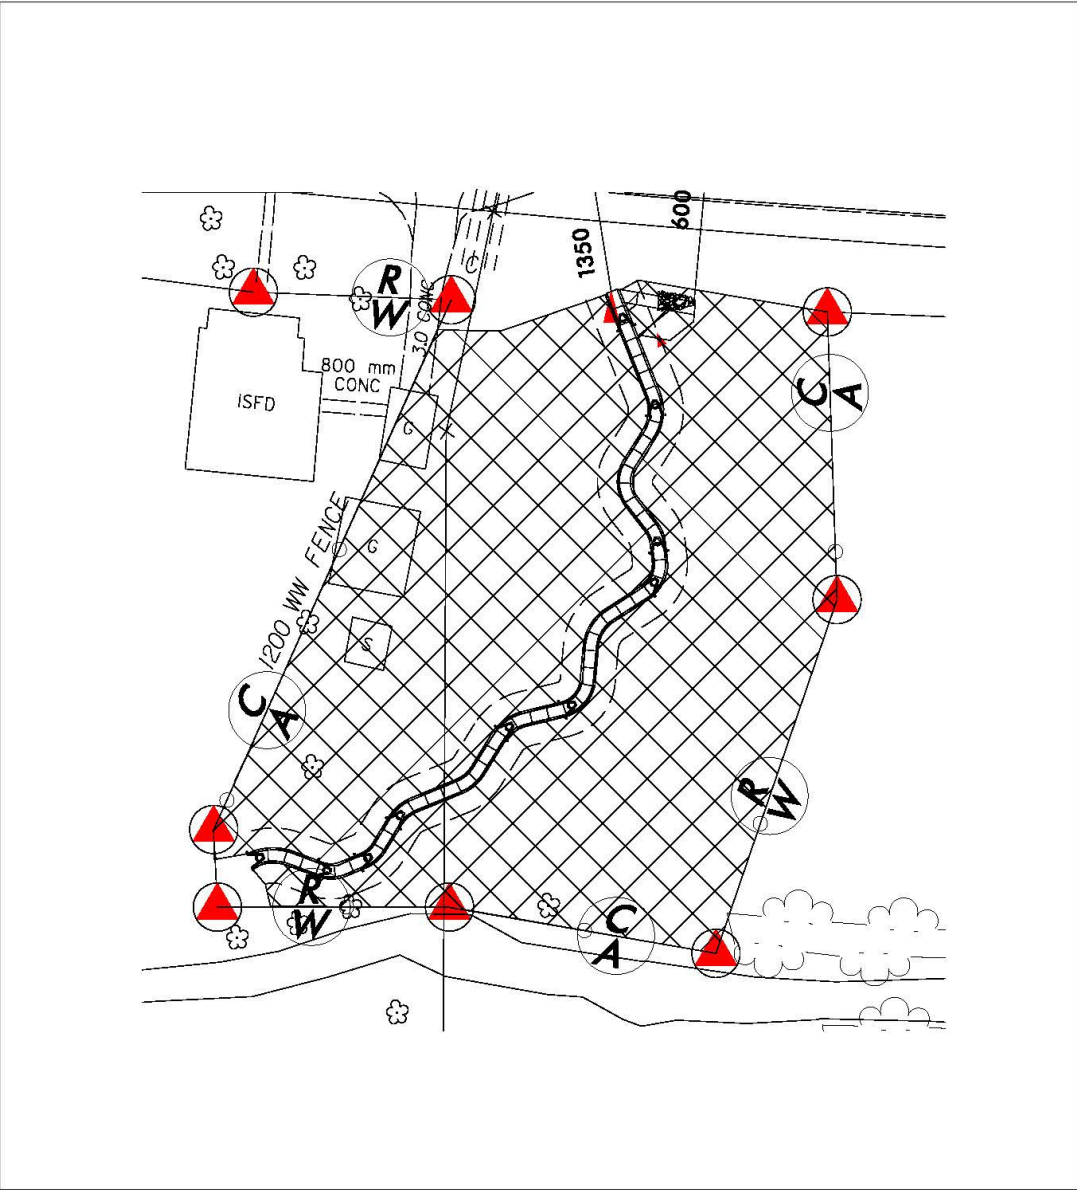
Figure 3. Site C Reforestation Map

STREAMBANK REFORESTATION FOR SITE C

Streambank & Buffer Vegetation: The streambank reforestation was completed in March 2012. The Year 4 vegetation monitoring evaluation noted: Type I: Black Willow, Silky Dogwood and Type II: Sycamore, Green Ash, Tulip Poplar and White Oak were surviving at the time of the monitoring evaluation.
